**Incident:**

**Root cause:**

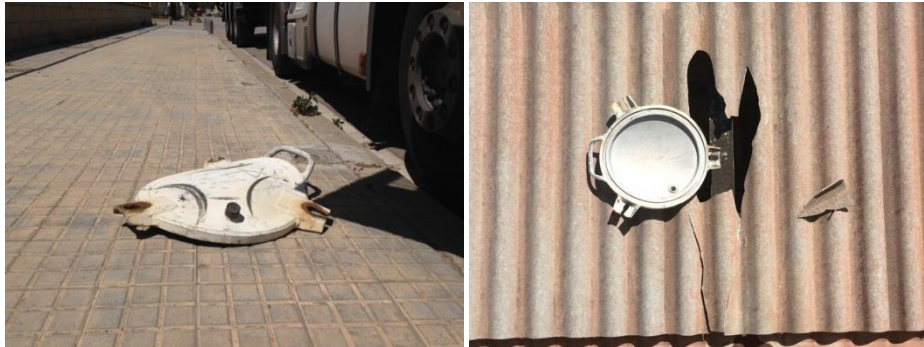
During unloading at one of our customers one of the manhole lids expelled during discharging. It went to the roof of the plant and broke the roof.

The pressure on the lid was during unloading with discharge pressure of around 0.9bar, 11000N.

The female screw of the lid was broken (inner screw-thread broke)

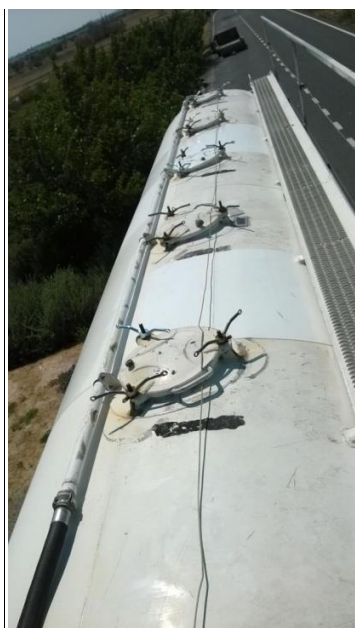
3 bolt system

The man lid system was one of the older systems. The lid is fixed on the silo with three bolts. See pictures.

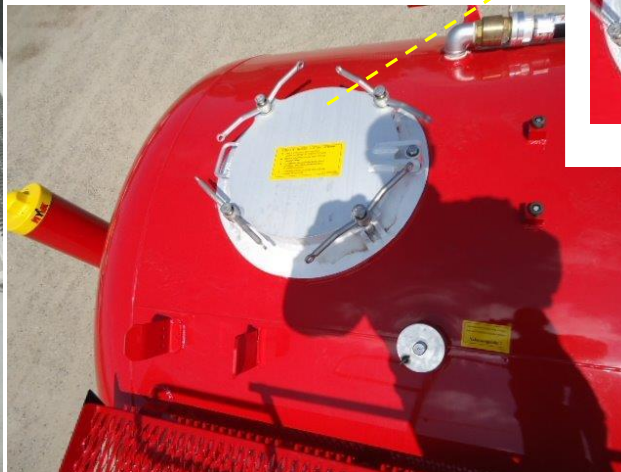
Newer systems are equipped with 4 fixing bolts and a hinge, which is connected at the silo. Most of these newer systems have also a safety head (see below pictures) on the screws which will prevent that the female lid of the screw can be expelled from the lid. This system is reducing the risk of expelled lids as happened during this incident.

System with 4 bolts and a hinge and safety head.
